**UNITED STATES DISTRICT COURT
NORTHERN DISTRICT OF CALIFORNIA**

CHART INC.

**COMPLAINT AND
DEMAND FOR JURY TRIAL**

I. Tank 4: A Chart MVE Cryopreservation Tank

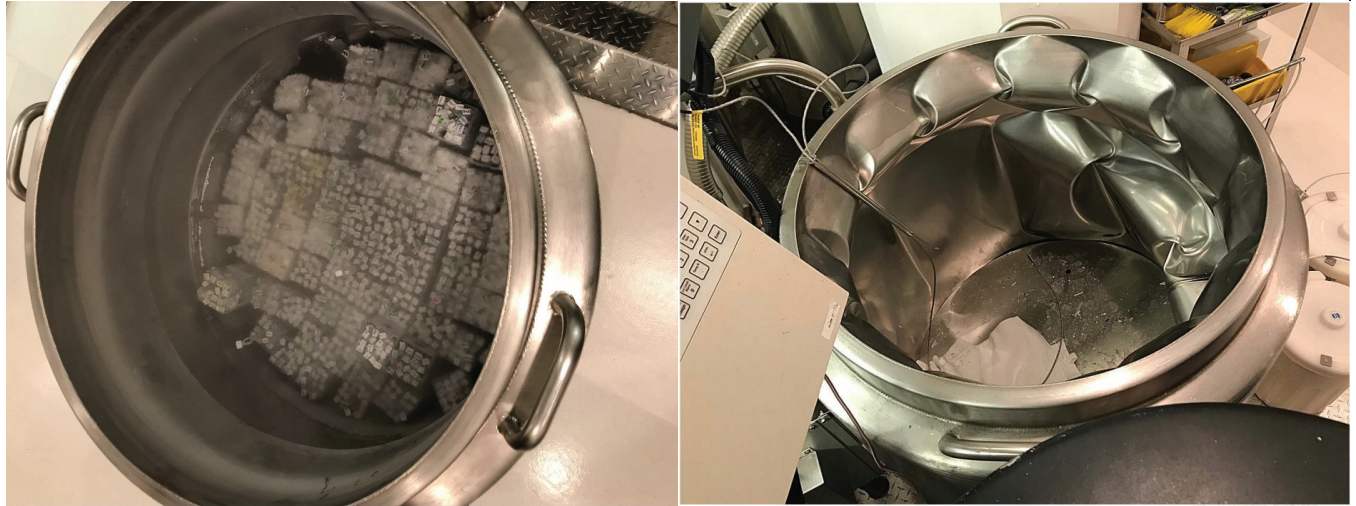
5. The cracked weld also triggered an implosion of the tank's inner vessel, as the liquid nitrogen that was sucked into the vacuum space transitioned to gaseous nitrogen and exerted pressure

on the inner vessel's walls. That is why the lid of the tank was difficult for PFC's embryologists to remove. The imploded tank is shown below, on the right:

Normal Tank

Imploded Tank

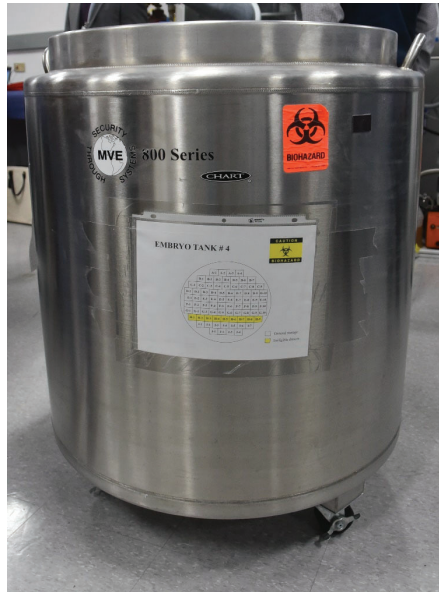
Tank 4

1 15. The tank at issue in this litigation is an MVE-branded cryopreservation tank—
2 specifically, a model MVE 808AF-GB Stainless Steel Freezer, which the embryologists at the Pacific
3 Fertility Center referred to as Tank 4:

15 16. The tank consists of the outer vessel seen above, an inner vessel that can be used to store
16 eggs and embryos in liquid nitrogen, and an insulated vacuum layer that separates the two vessels and
17 prevents heat transfer from the surrounding environment.

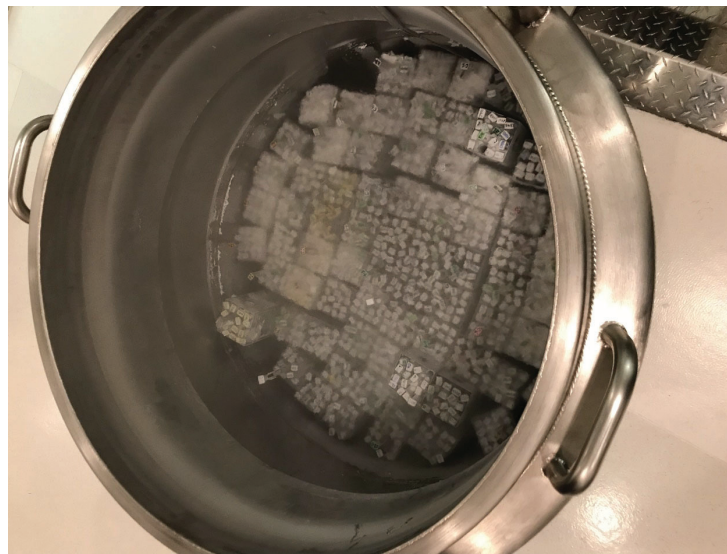
18 17. The tank's inner vessel is shown below:

1 18. The tank is filled with liquid nitrogen and dozens of boxes, each with further dividers
2 that collectively can house hundreds of slender vitrification devices used to collect each respective egg
3 or embryo.

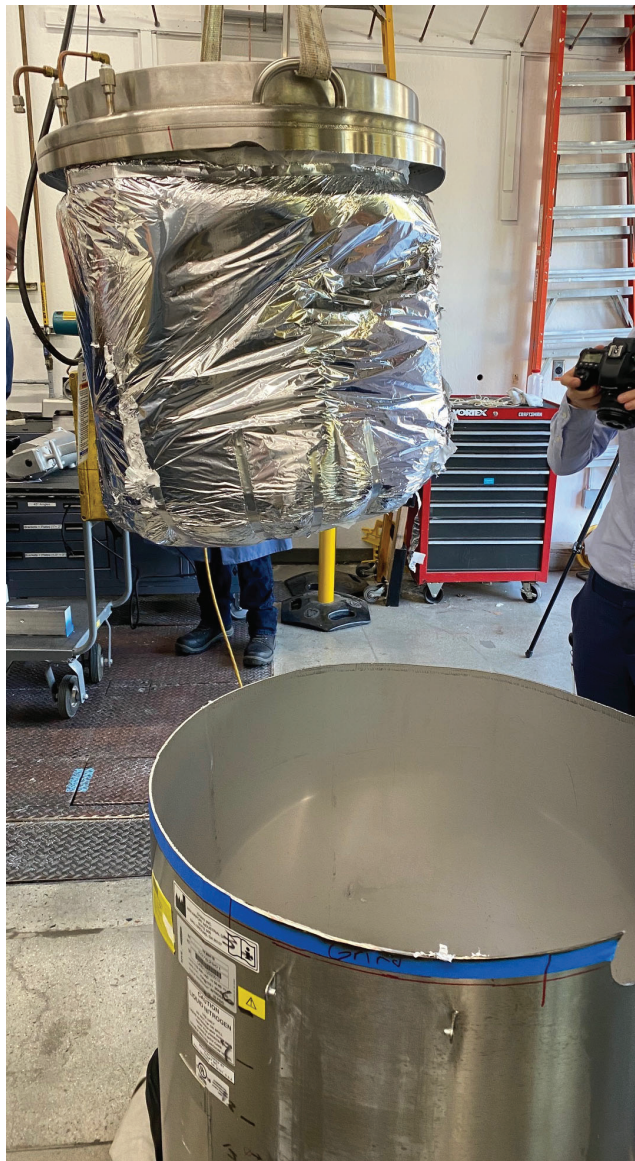
4 19. The picture below was taken following failure of Tank 4 and shows the tank's inner
5 vessel (wrapped in reflective material) being removed from the outer vessel. In between the two vessels
6 was an interstitial space. Before a tank is put into service, Chart draws a vacuum within that space by
7 sealing it shut and pumping out the air. The resulting vacuum space is what allows cryopreservation
8 tanks to keep liquid nitrogen and biological samples at -198°C .

*Tank 4's inner vessel suspended after removal
from outer vessel (vacuum space was in between)*

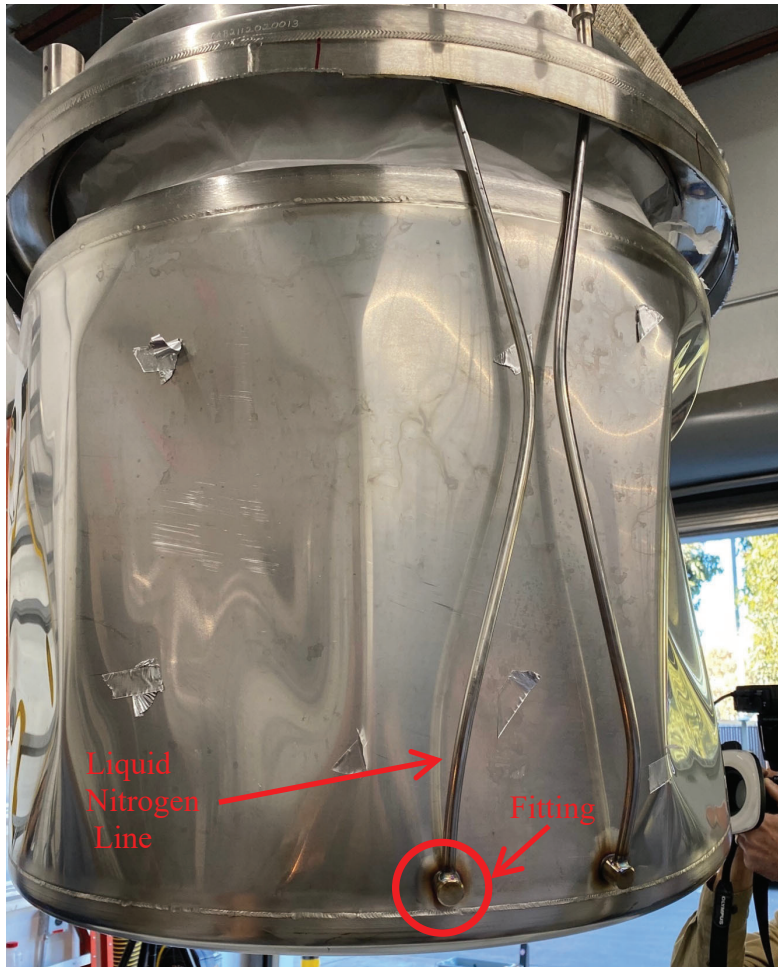
25. The picture below was taken after the outer vessel of Tank 4 was removed. The liquid nitrogen tube is on the left and the red circle shows where it connects to the inner vessel through a fitting.

Liquid nitrogen tube feeds into Tank 4's inner vessel

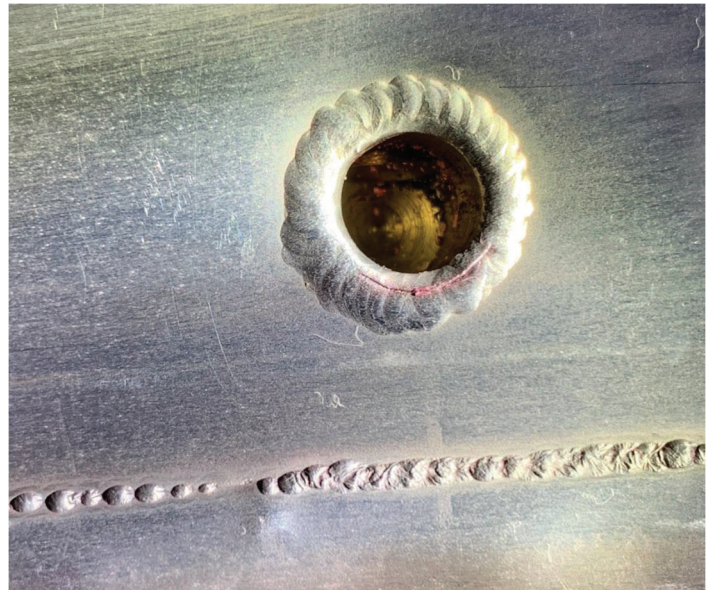
5 27. The image on the right is the same weld, this time after using Magnaflux Spotcheck
6 liquid dye penetrant. The fact the red dye penetrant remained after the surface was wiped clean is
7 indicative of a crack.

Red dye indicates a crack in the weld

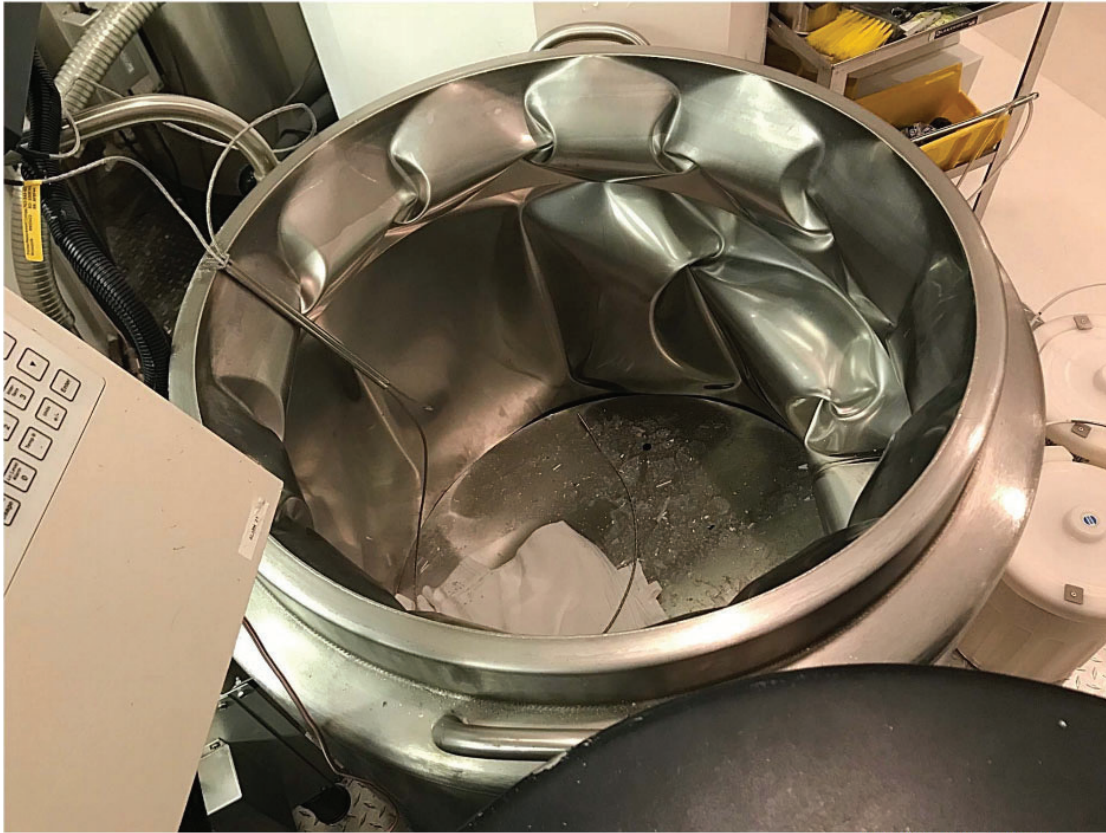
Tank 4 after the incident

32. When the faulty weld cracked, the vacuum space was no longer separated from the inner vessel where PFC kept its patients' eggs and embryos. Liquid nitrogen was sucked into the vacuum space, where it expanded into nitrogen gas and pressurized the space between the inner vessel and outer vessel.

33. The crack and accompanying leak of liquid nitrogen into the interstitial space both destroyed the vacuum insulation that allowed the inner vessel to stay cold and exerted significant pressure on the space between the tank's inner and outer vessel. The inner vessel gave way and crumpled. The following image was taken approximately 36 hours after the PFC embryologists discovered the Tank 4 failure and moved the affected eggs and embryos to another tank.

34. This dramatically imploded tank is yet another indication of a cracked failure. As part of its compliance with the European Union's Medical Device Directive, Chart was required to attempt to identify every way that its cryogenic freezers could theoretically fail. Representatives from Chart's various departments came up with over a hundred potential failure modes. One of them was a cracked weld at the liquid nitrogen fill tube—exactly what expert analysis revealed happened to PFC's Tank 4. If that weld did crack, Chart wrote that the result would be: "Liquid draws into vacuum space, expanding rapidly and causing an inner vessel implosion, total vacuum loss. Loss of function of the freezer."
